Borough of Caldwell

Phase II Inflow and Infiltration Investigation

December 28, 2021

Extraneous Flow Evaluation

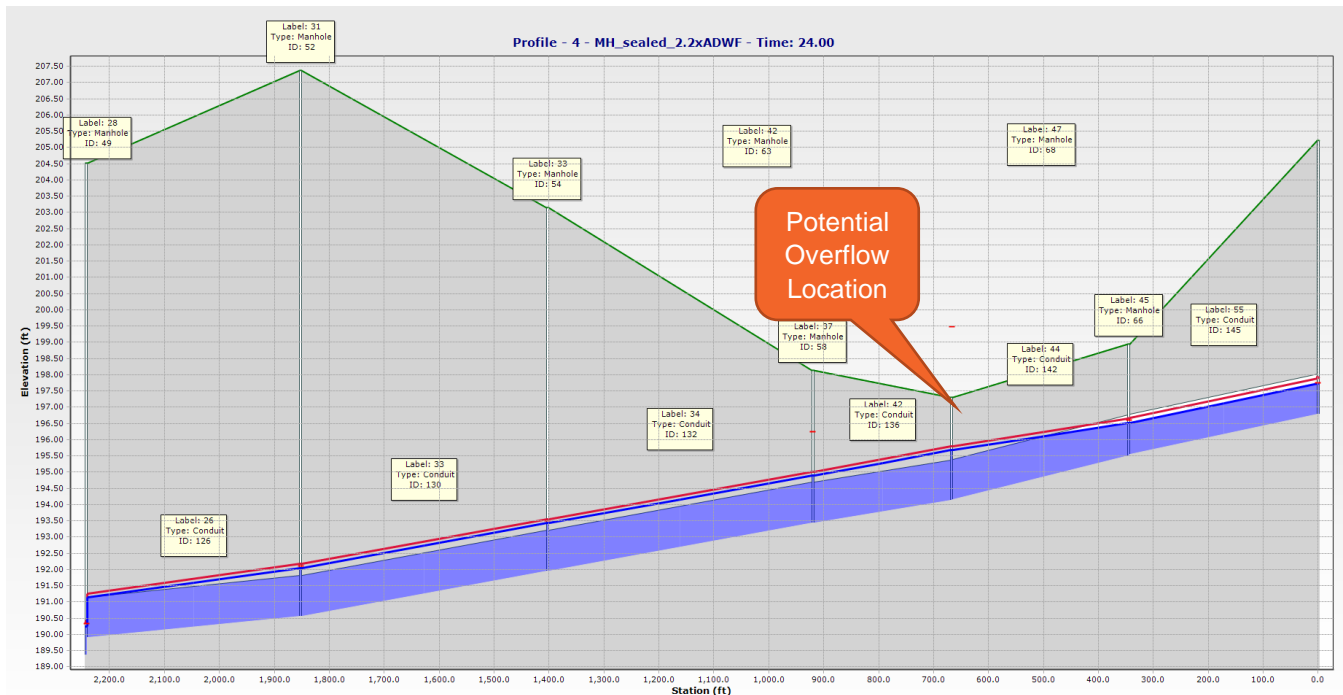
Figure 8: 15-inch dia. Passaic Avenue Interceptor Profile - Potential Overflow Location

Model data tables and profiles were visually scanned for missing geometry, physical data values defaulted to null and adverse (i.e.: negative or flat) pipe slopes. The model was also reviewed for likely points of early failure. For example, **Figure 7** and **Figure 8** show a potential surface overflow location along Passaic Avenue.

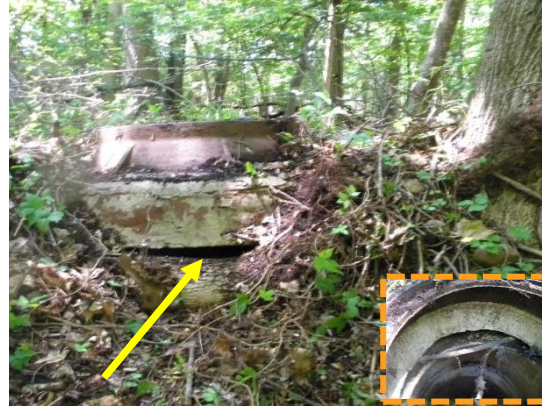
Figure 12: East Branch Fullerton Interceptor MH FB-7

Arrow points to inflow source (void wedged-open by tree root) below ring section. Inset shows internal view of tree root through void.

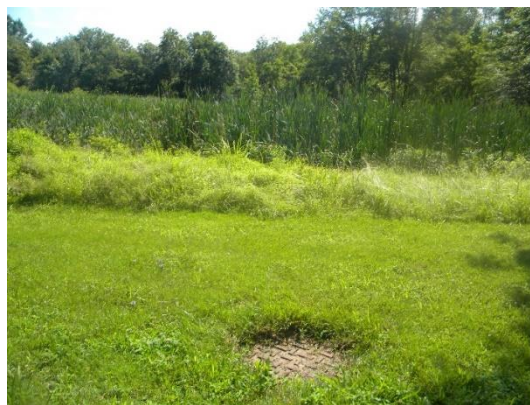
Figure 13: Green Brook Interceptor MH GB-38

View of cover two (2") inches below grade; susceptible to inflow from surface ponding.

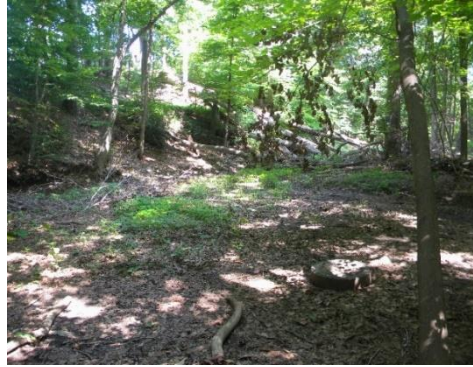
Figure 14: Pine Brook Interceptor MH PB-9

View of flood-prone cover (susceptible to inflow) near Pine Brook.

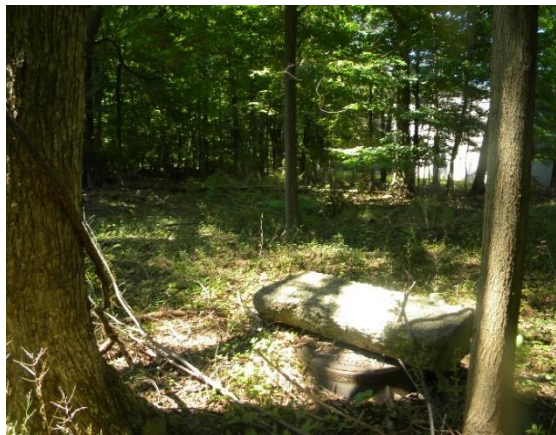
Figure 15: York Avenue Interceptor MH YA-4

View of flood-prone cover (susceptible to inflow) with concrete slab atop cover suggesting SSOs have occurred.
