ENGINEERING REPORT

March 31, 2023

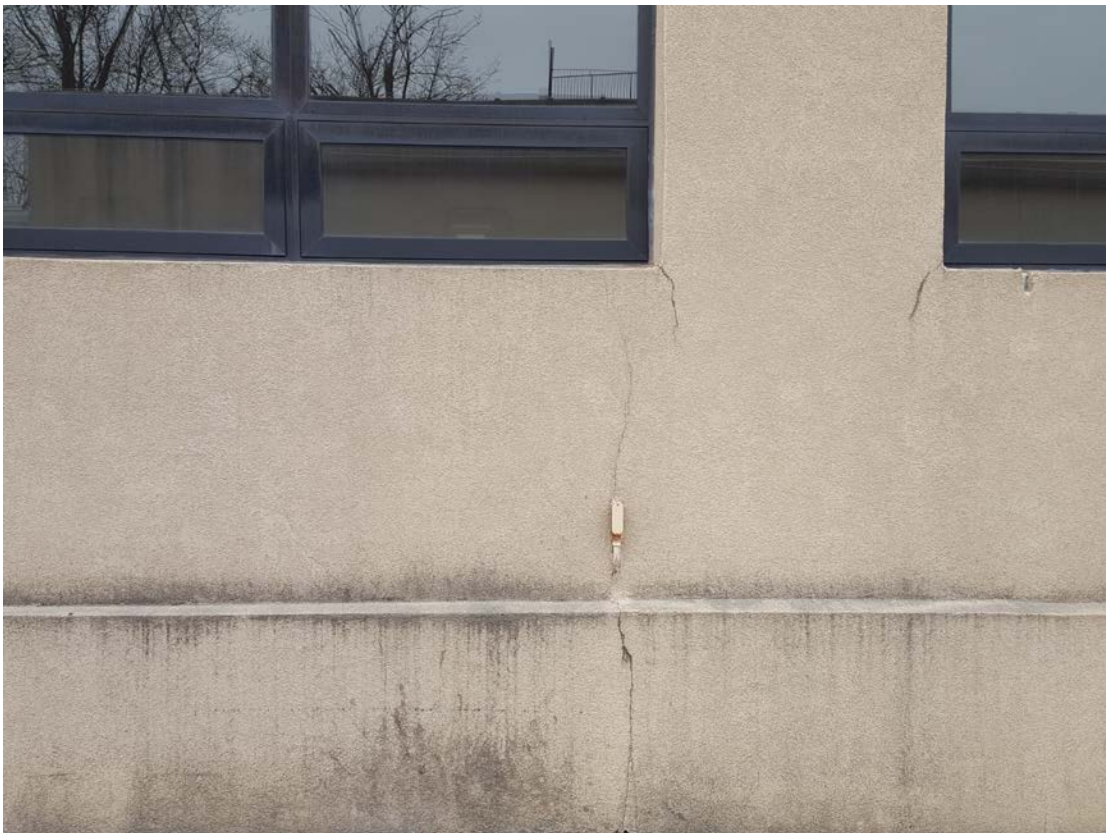
Photo #8 – Stress Cracking in Exterior Wall (North).

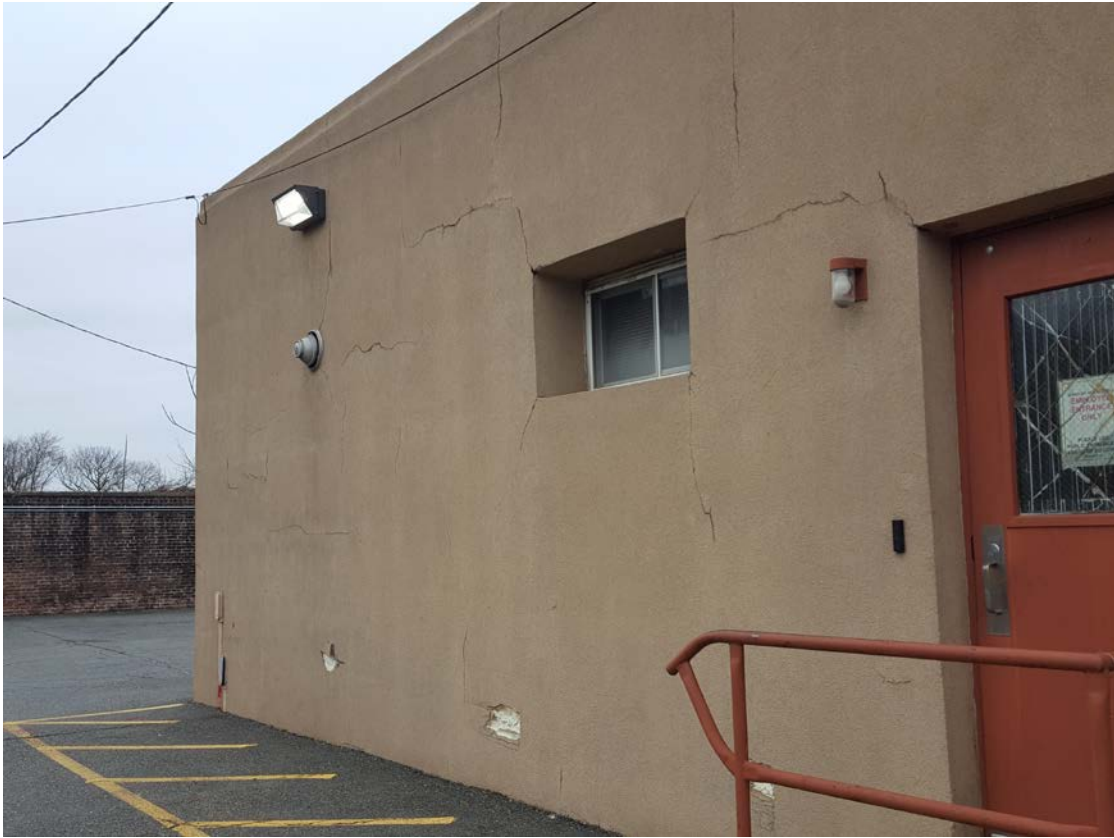
Photo #9 – Stress Cracking in Exterior Wall (East).

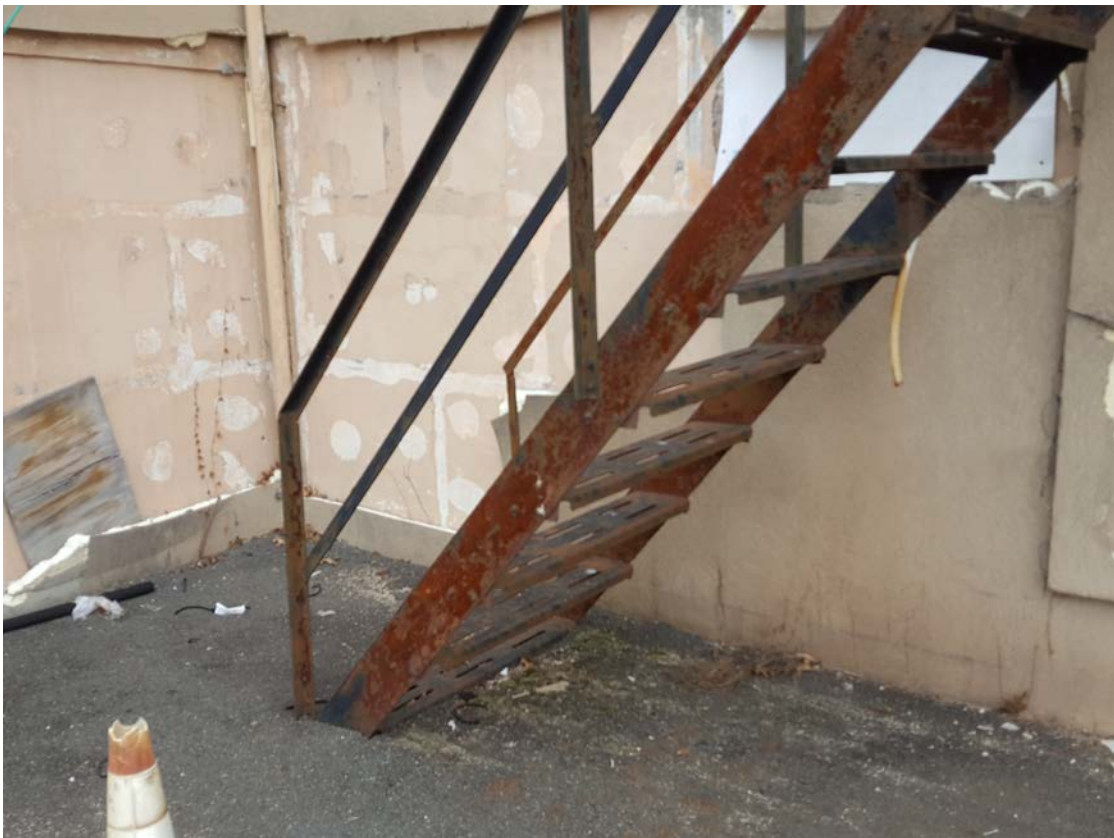
Photo #10 – Surface Rusted Fire Escape & Large Sections of EIFS Removed/Missing.

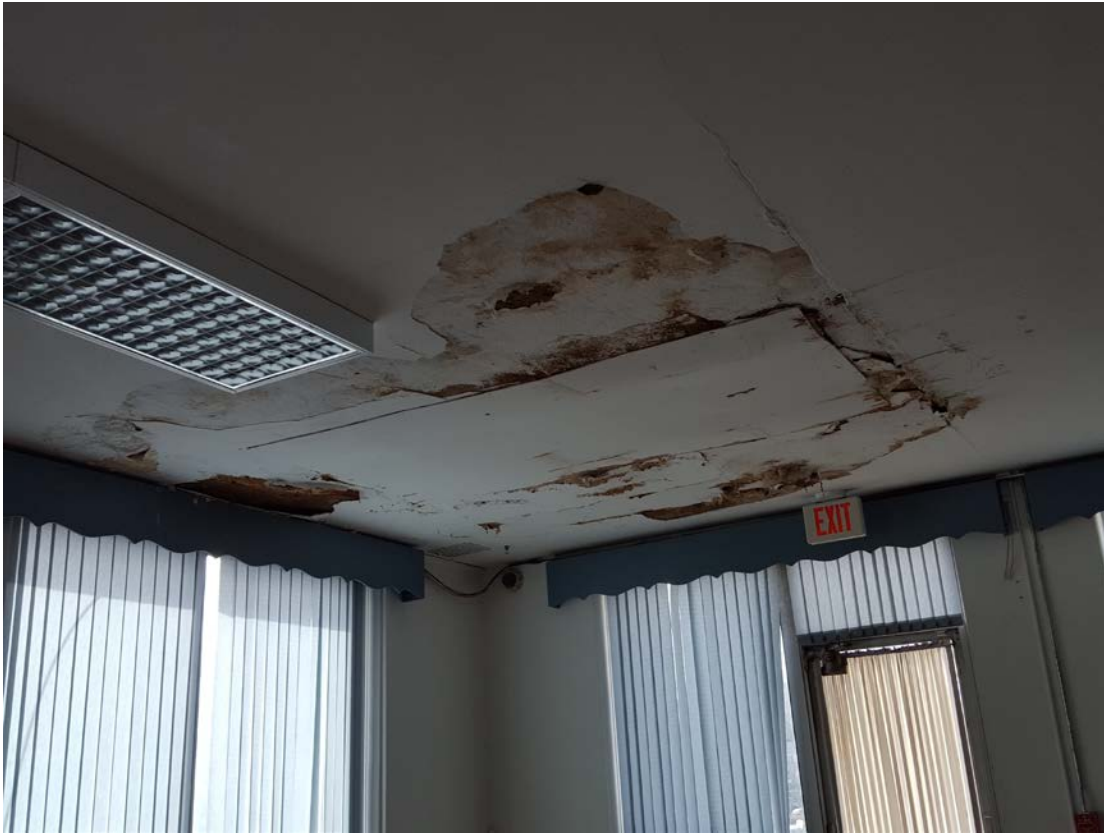
Photo #11 – Water Damaged Ceiling at Southeast End of Courtroom.

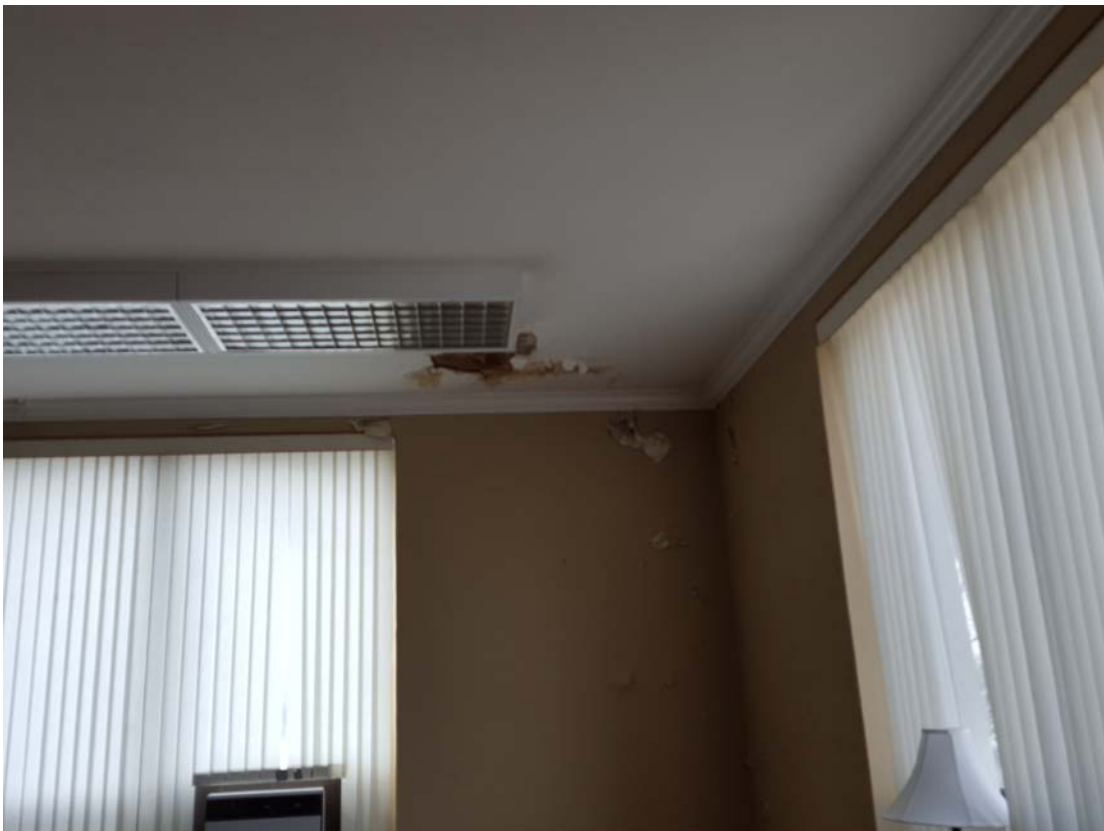
Photo #12 – Water Damaged Ceiling Northwest Corner.

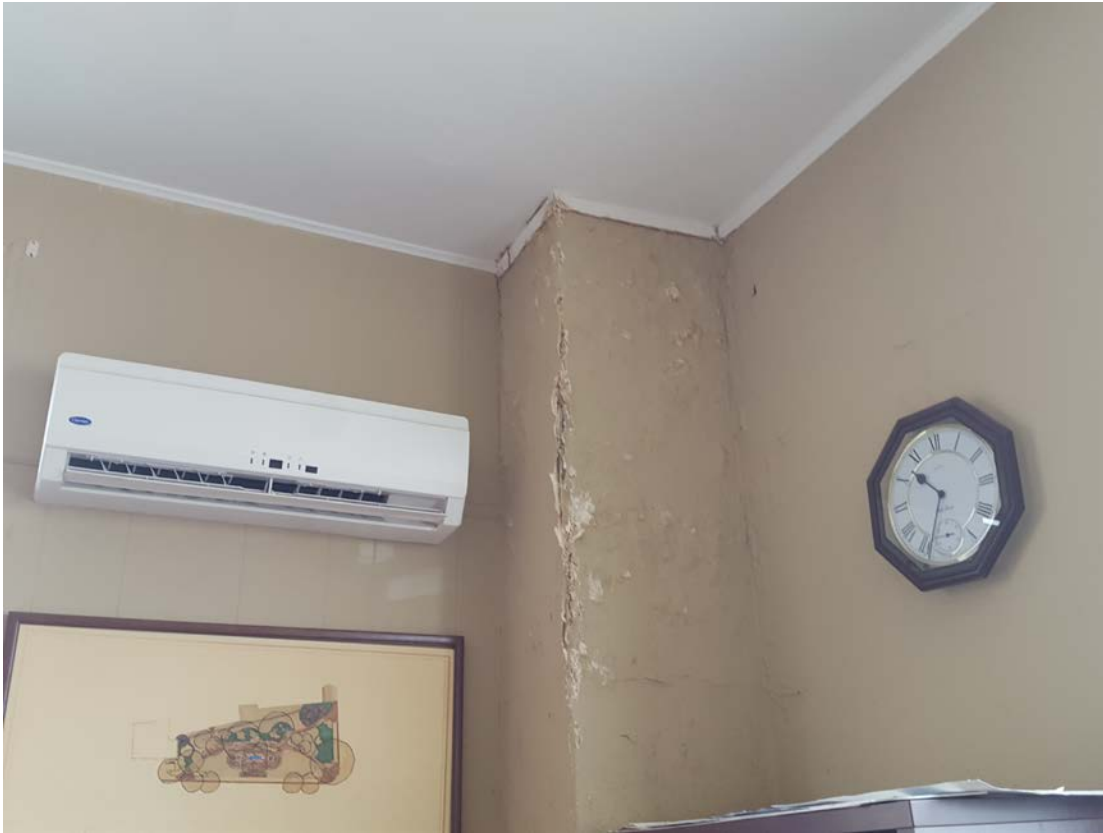
Photo #13 – Southwest Corner Chimney/Chase with Water Damage.

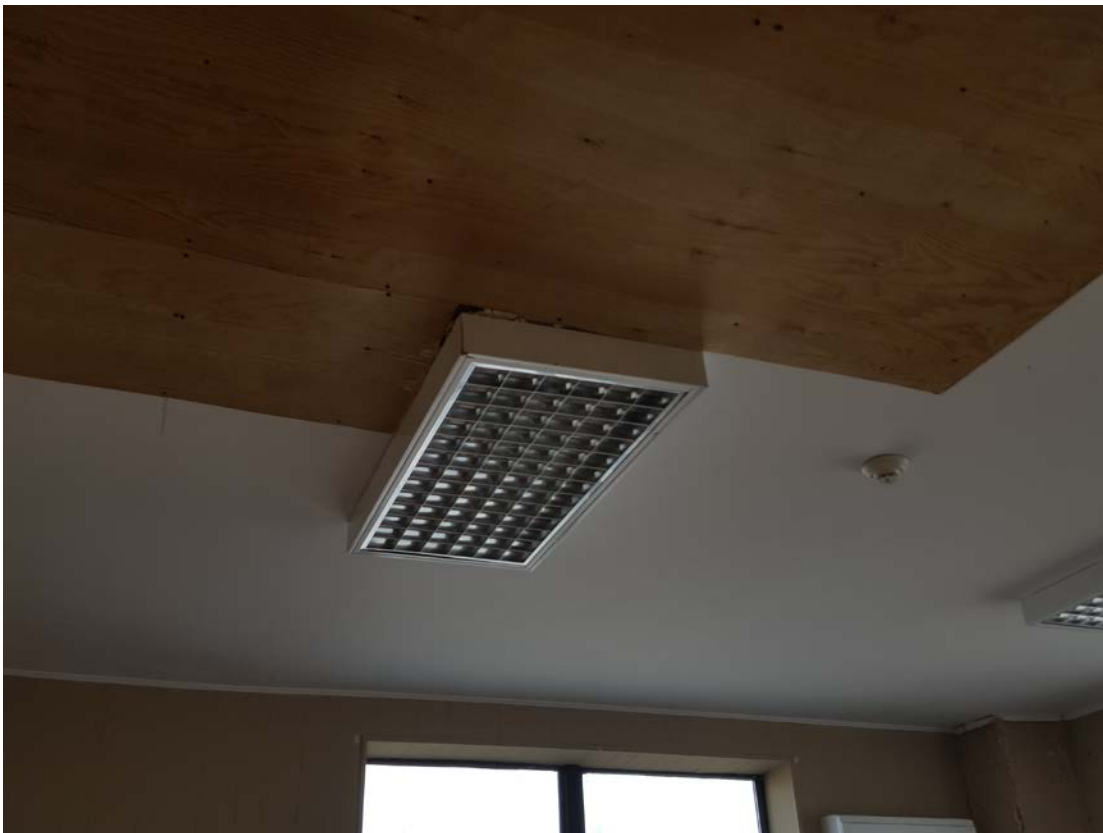
Photo #14 – Temporary Ceiling Repairs.

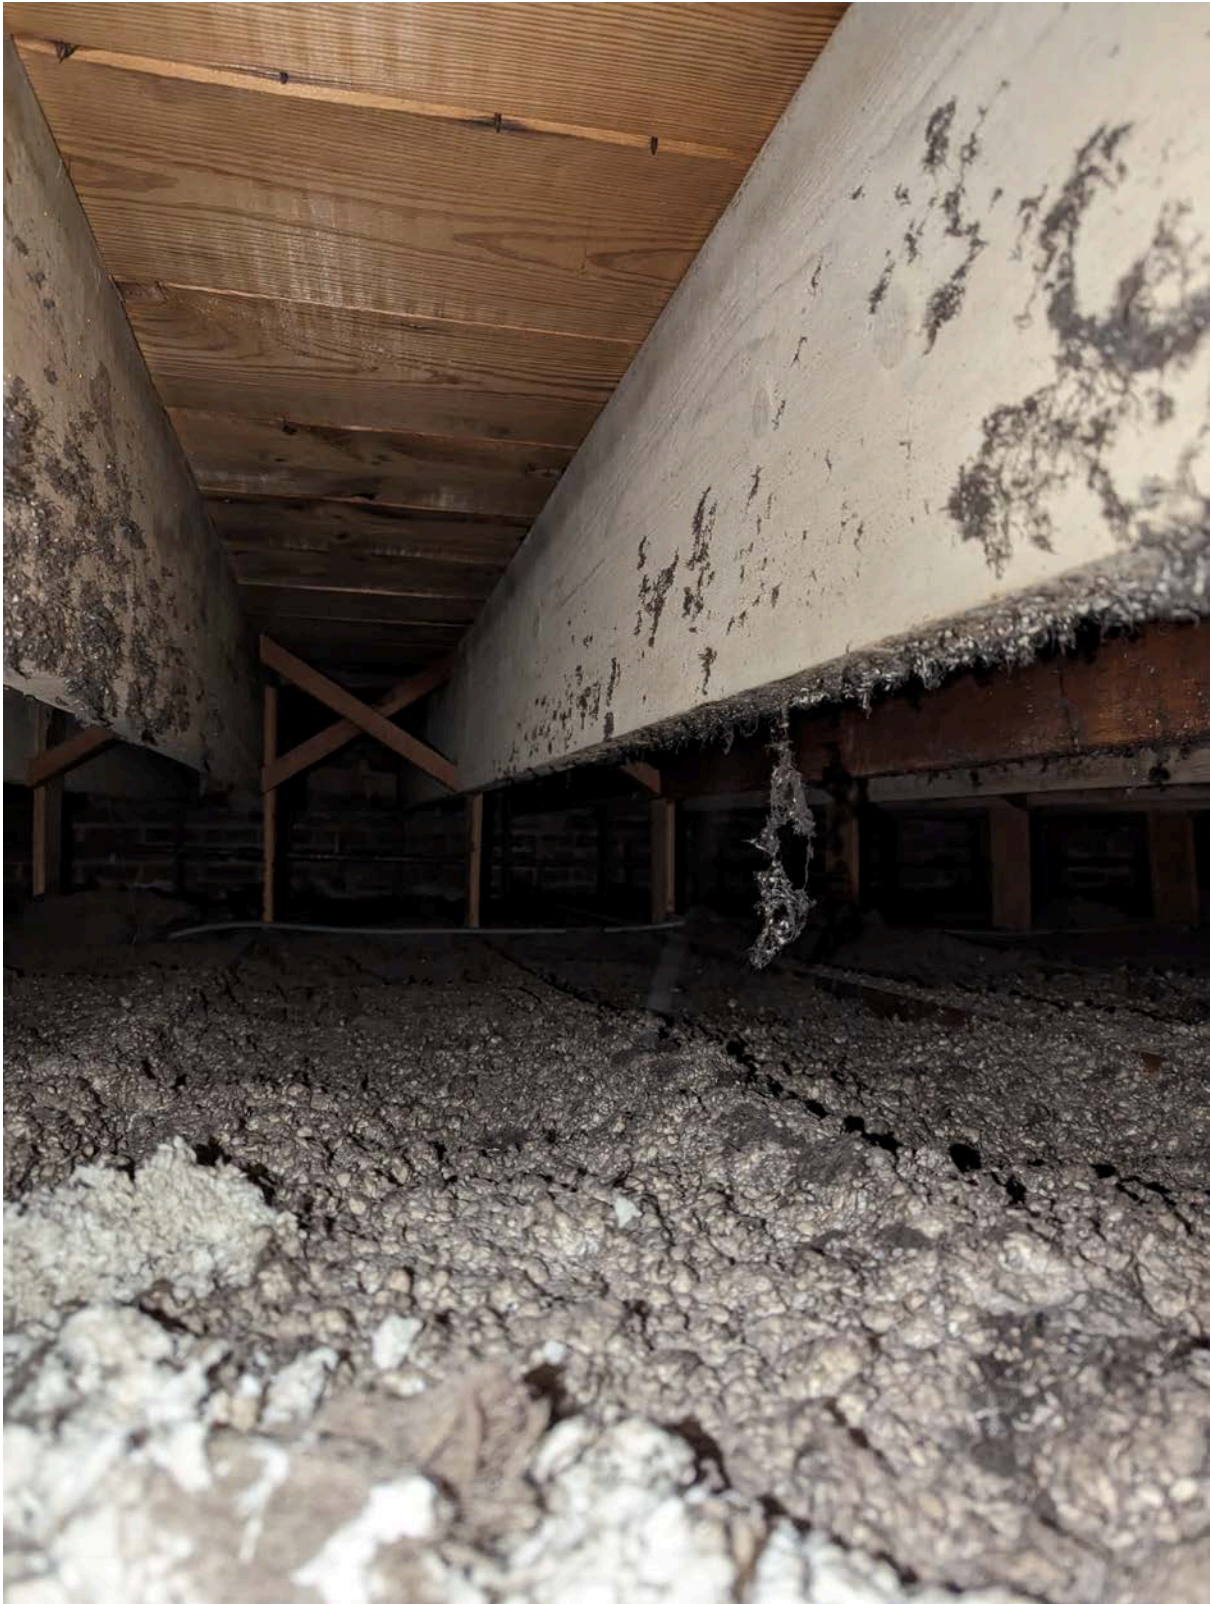
Photo #15 – View of Ceiling Cavity below Roof at Non-water Damaged West End.

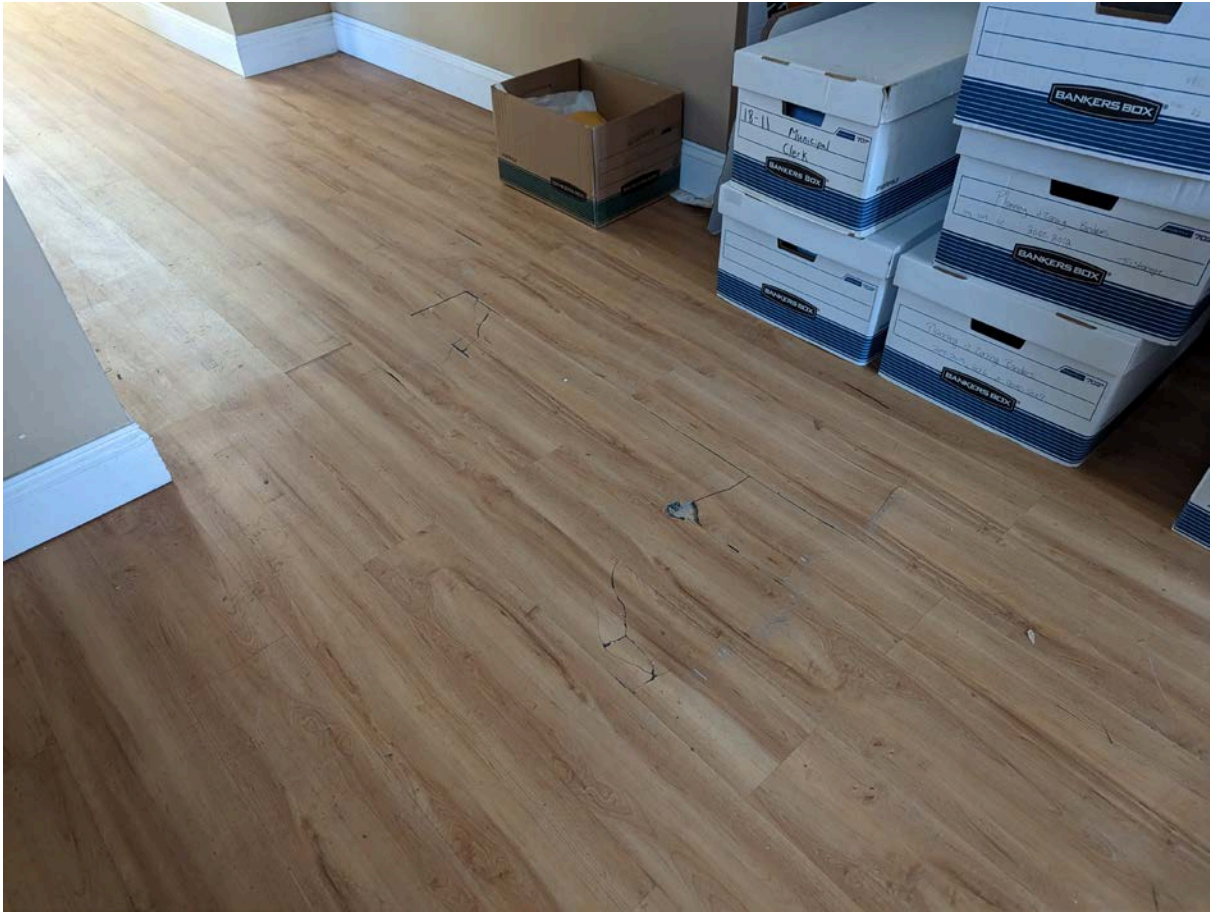
Photo #24 – Damage to First Floor Finish – Sleepers over Slab on Grade.
