## ENGINEERING REPORT

March 31, 2023

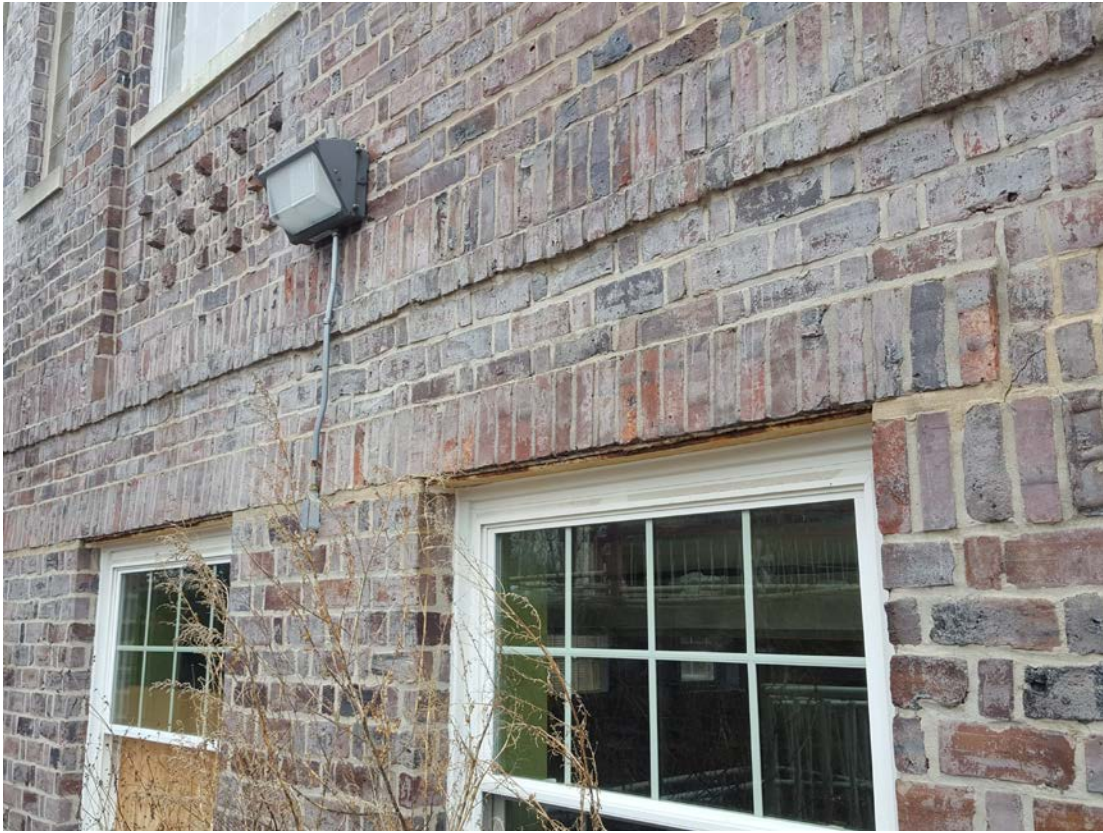
Photo #9 – Deteriorated Steel Lintels over Windows.

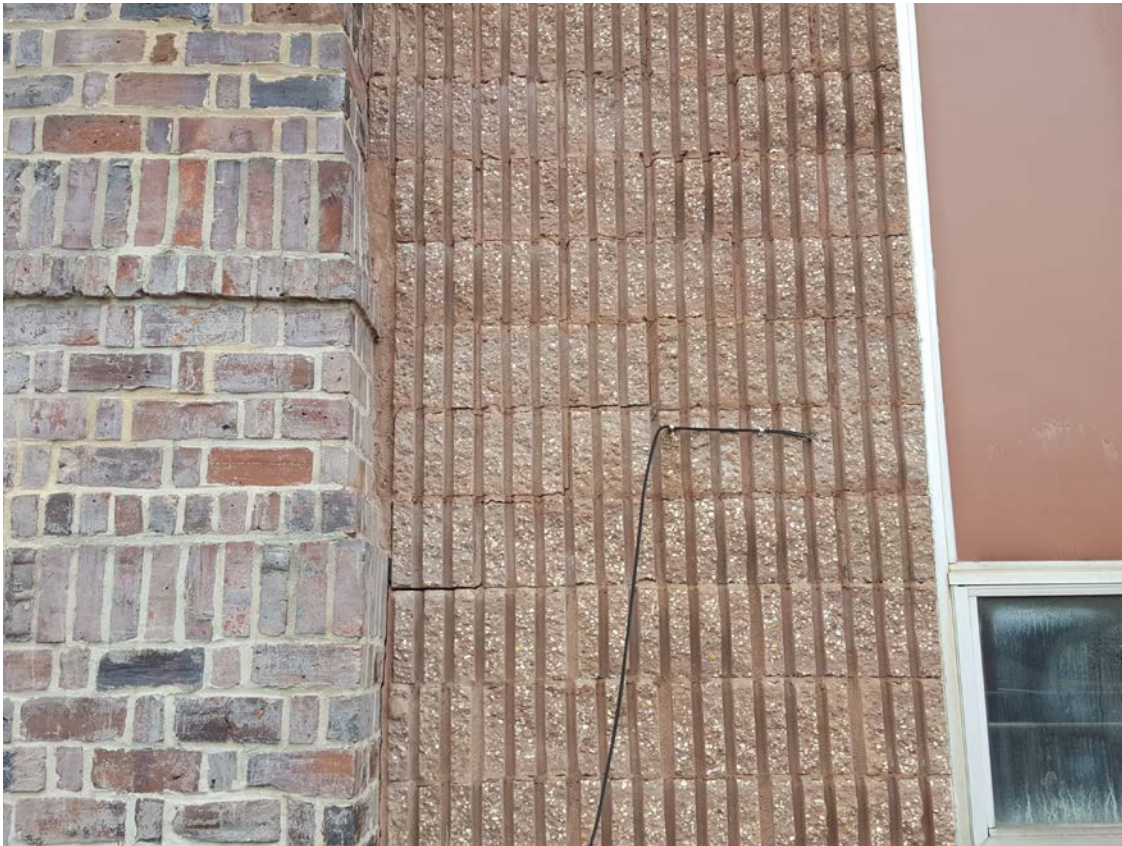
Photo #10 – Stepped Cracking in Façade.

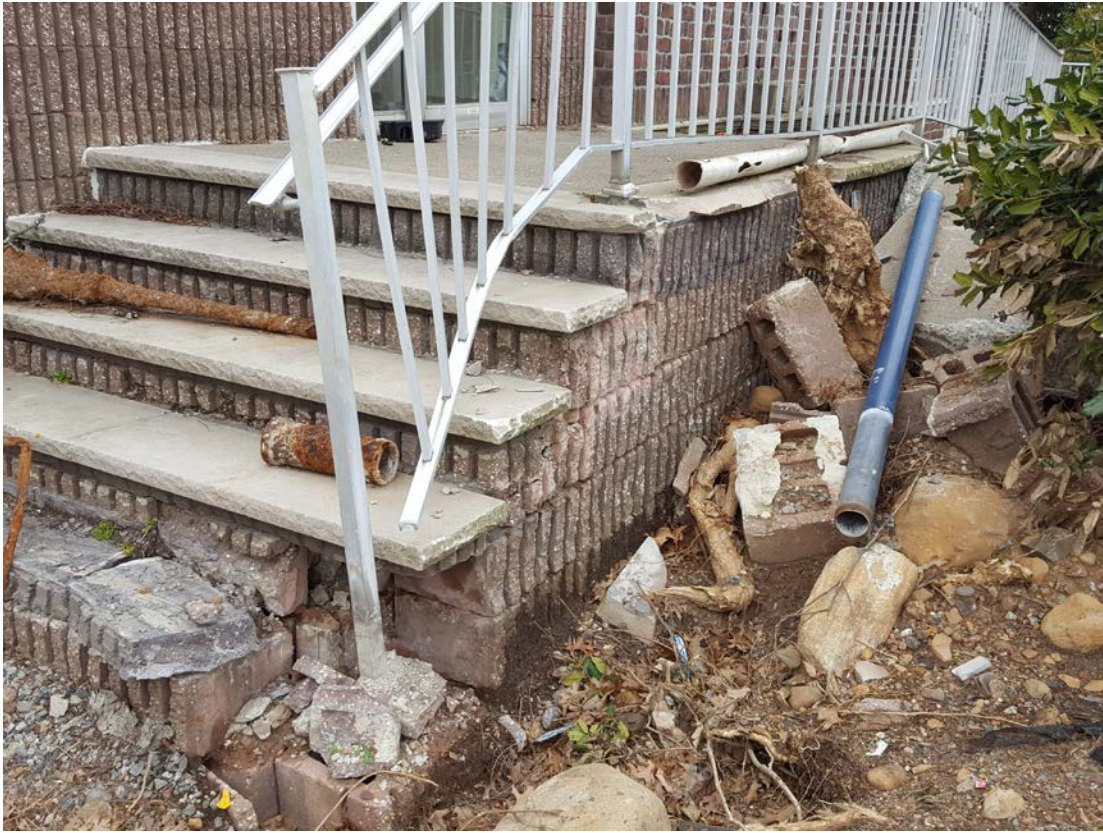
Photo #11 – Damaged Front Entry Steps, Guardrail & Ramp.

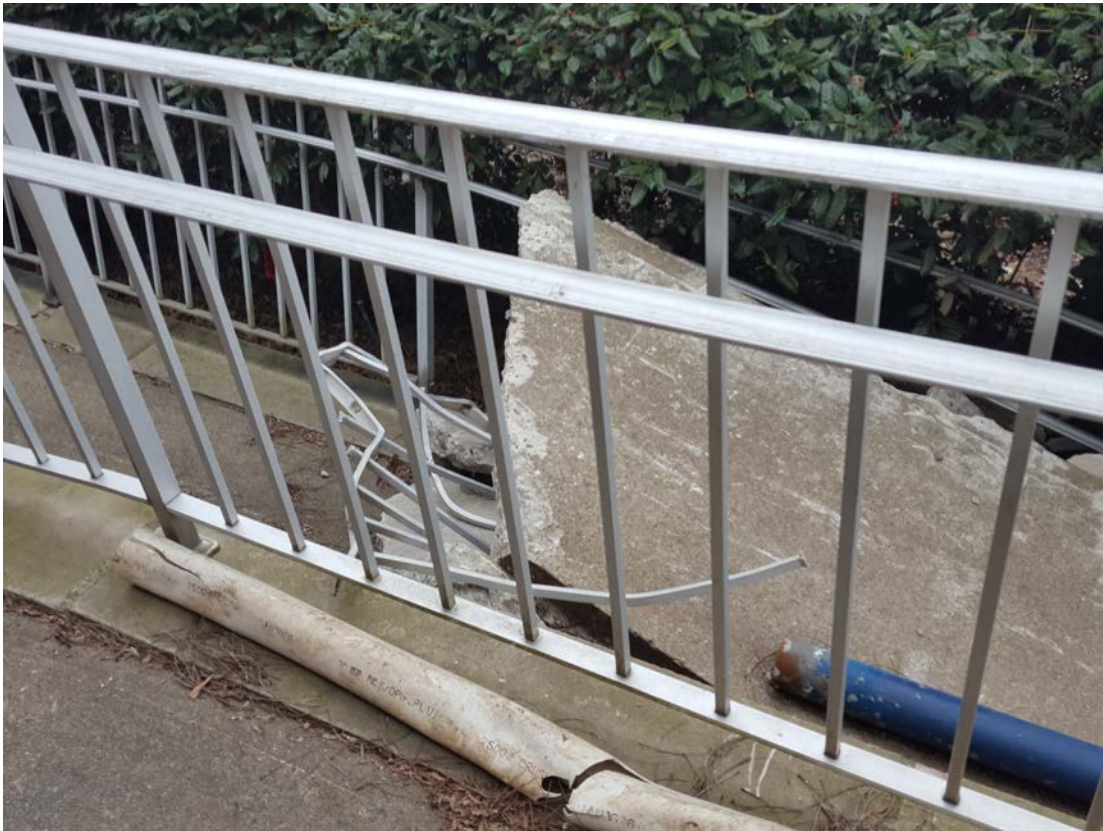
Photo #12 – Damaged Front Entry Ramp.

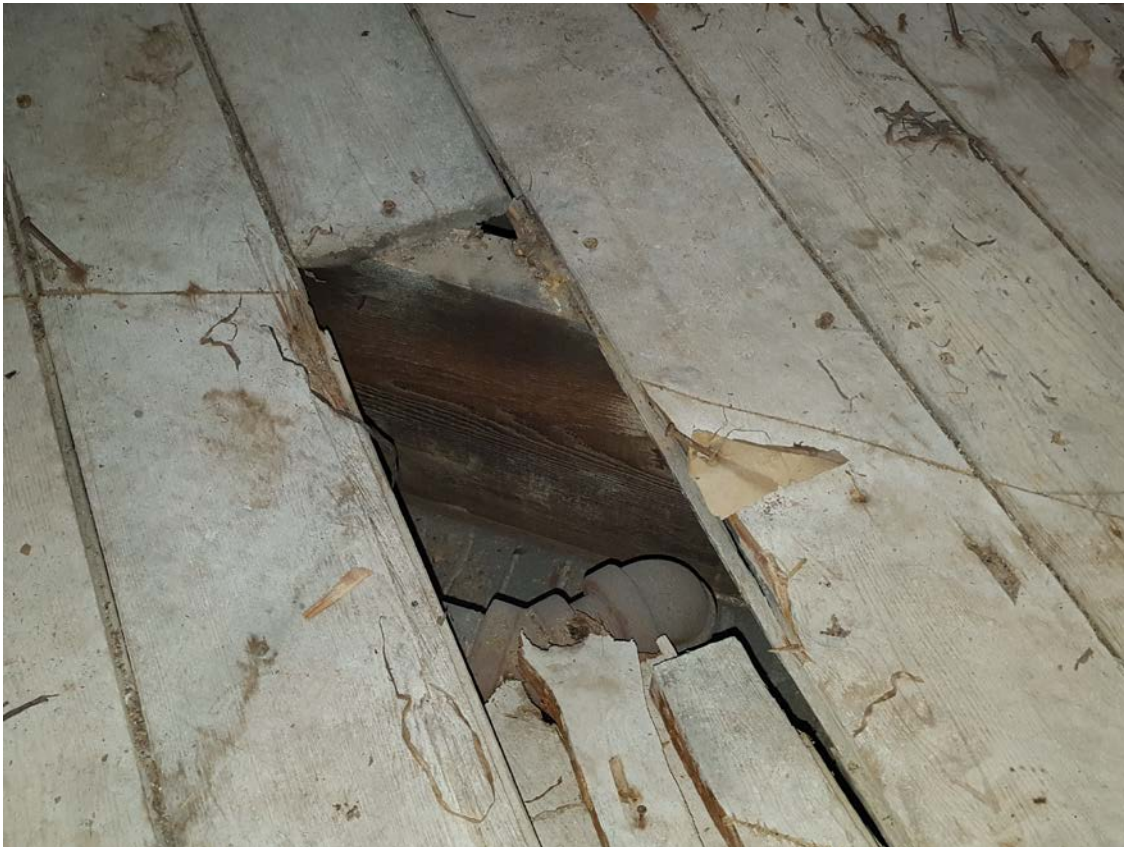
*Photo #16 – Damaged Floor Sheathing Sporadic Throughout Wood First Floor.*

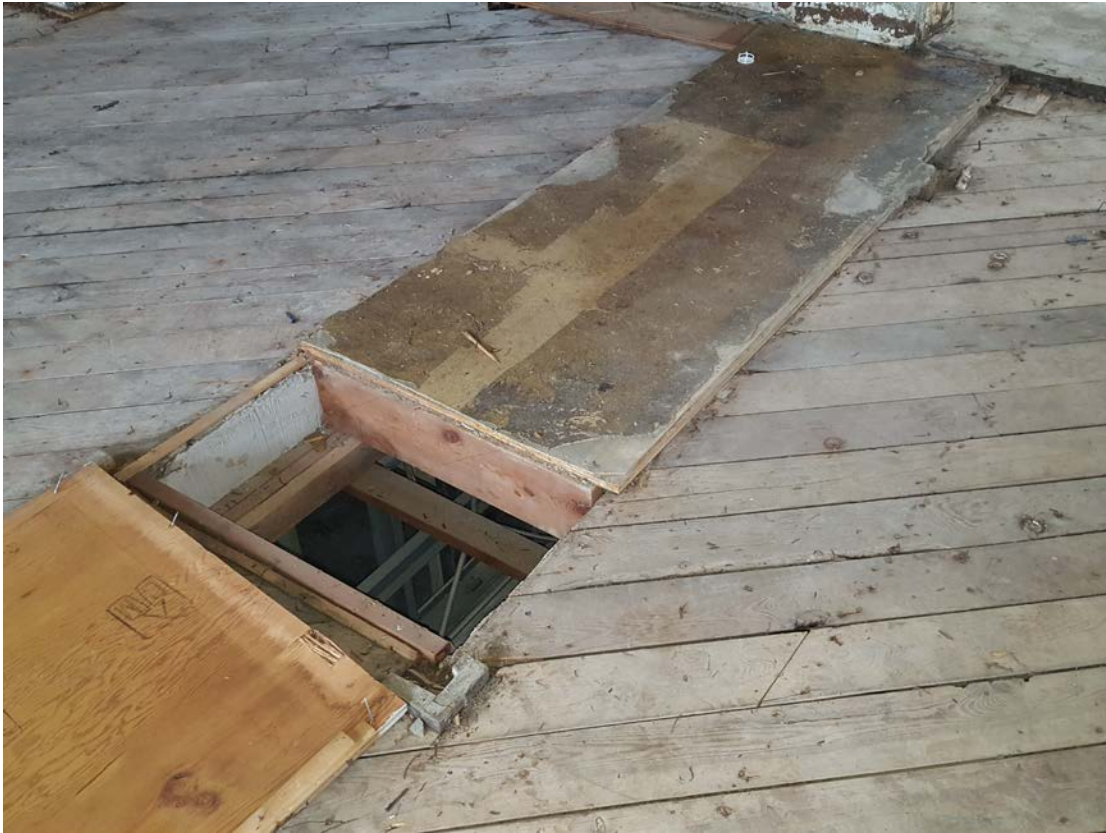
*Photo #17 – Opening in Floor with Miscellaneous Blocking & Loose Plywood Covering.*

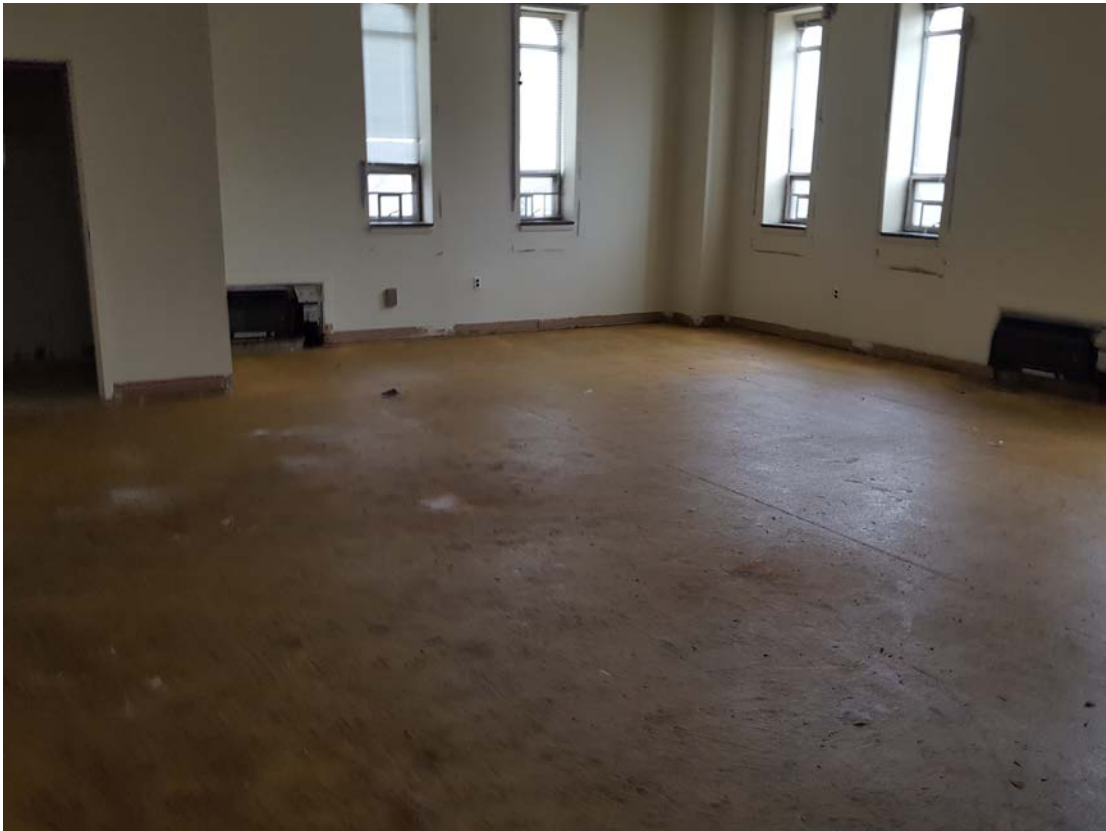
*Photo #18 – Rear Addition Space – First Floor.*

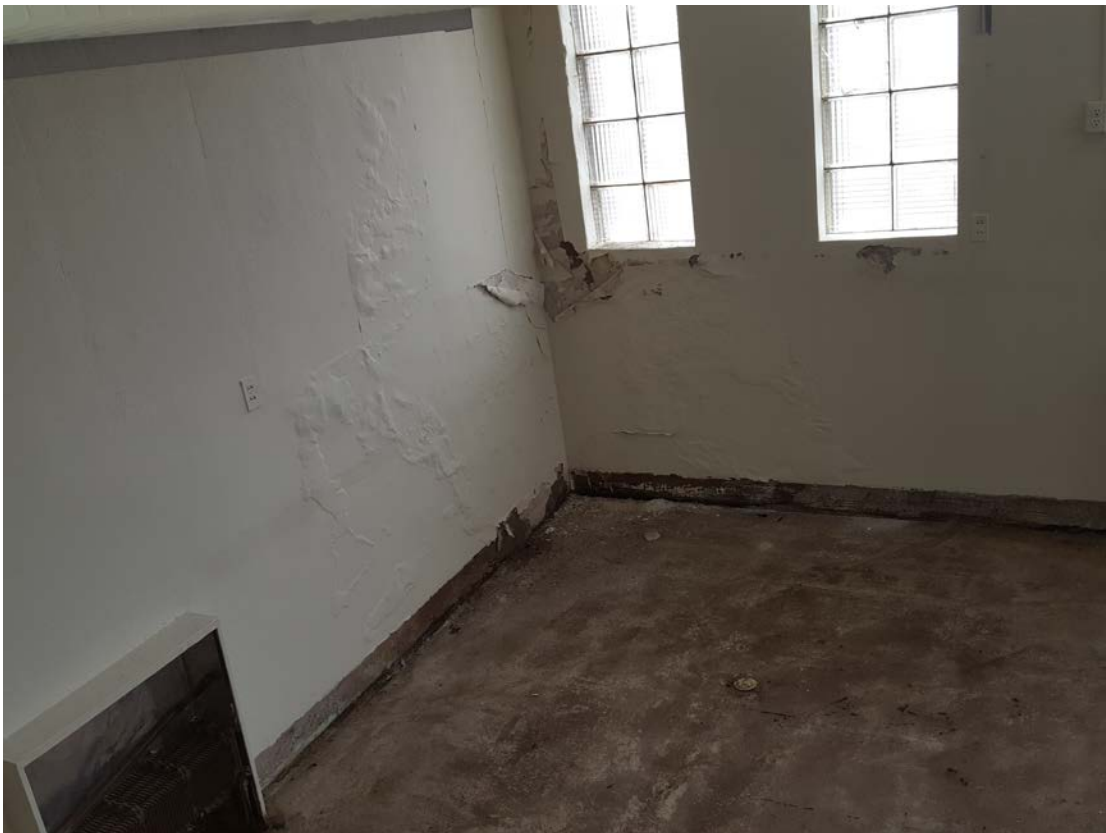
Photo #20 – Moisture Damage of Interior Finish/Paint Located at Southwest Section.

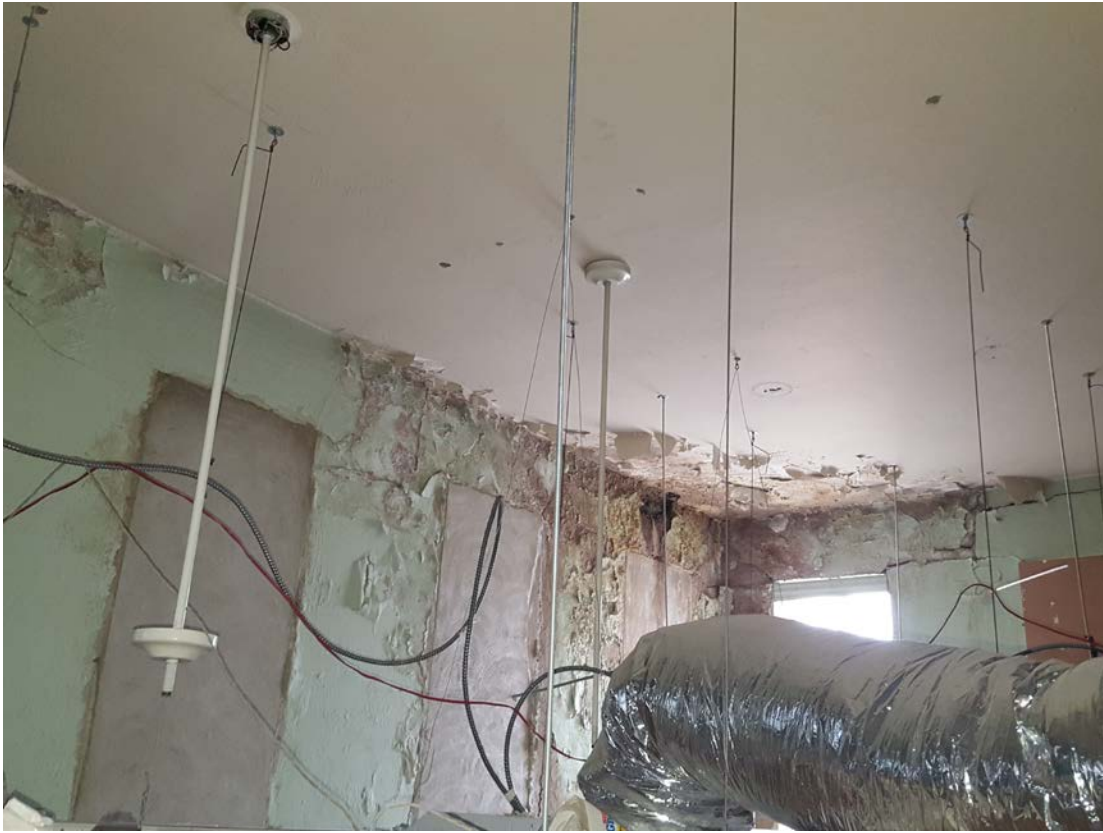
Photo #21 – High Moisture Damage above Photo #20.

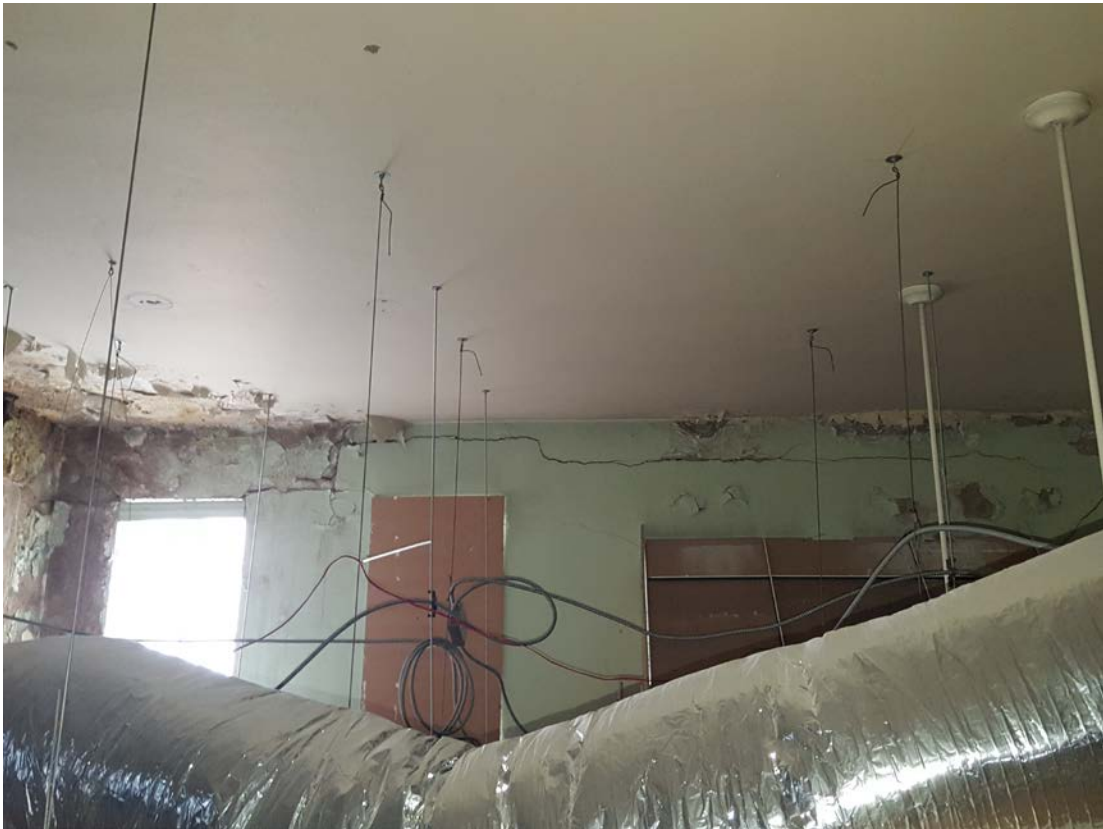
Photo #22 – Horizontal Masonry Cracking at Southwest Section – Located at South Wall.

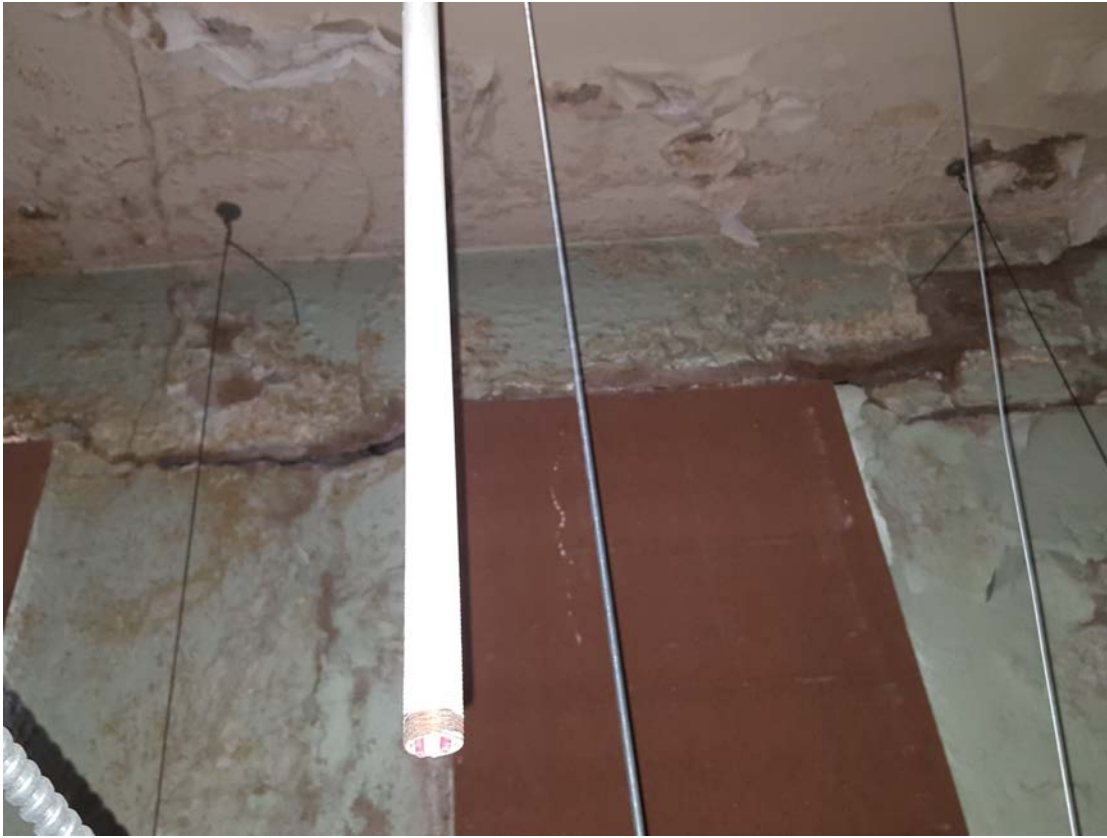
*Photo #23 – Horizontal Masonry Cracking at Southwest Section – Located at West Wall.*

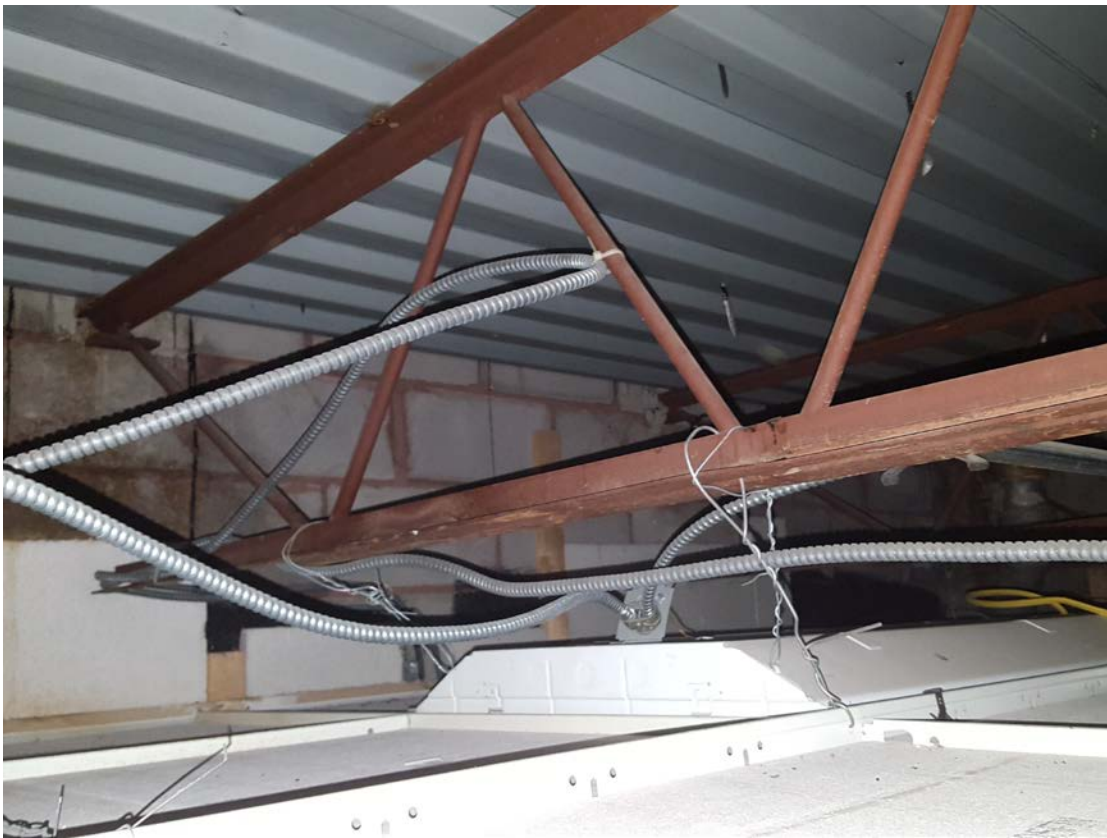
*Photo #24 – Typical Roof Construction at East Addition.*

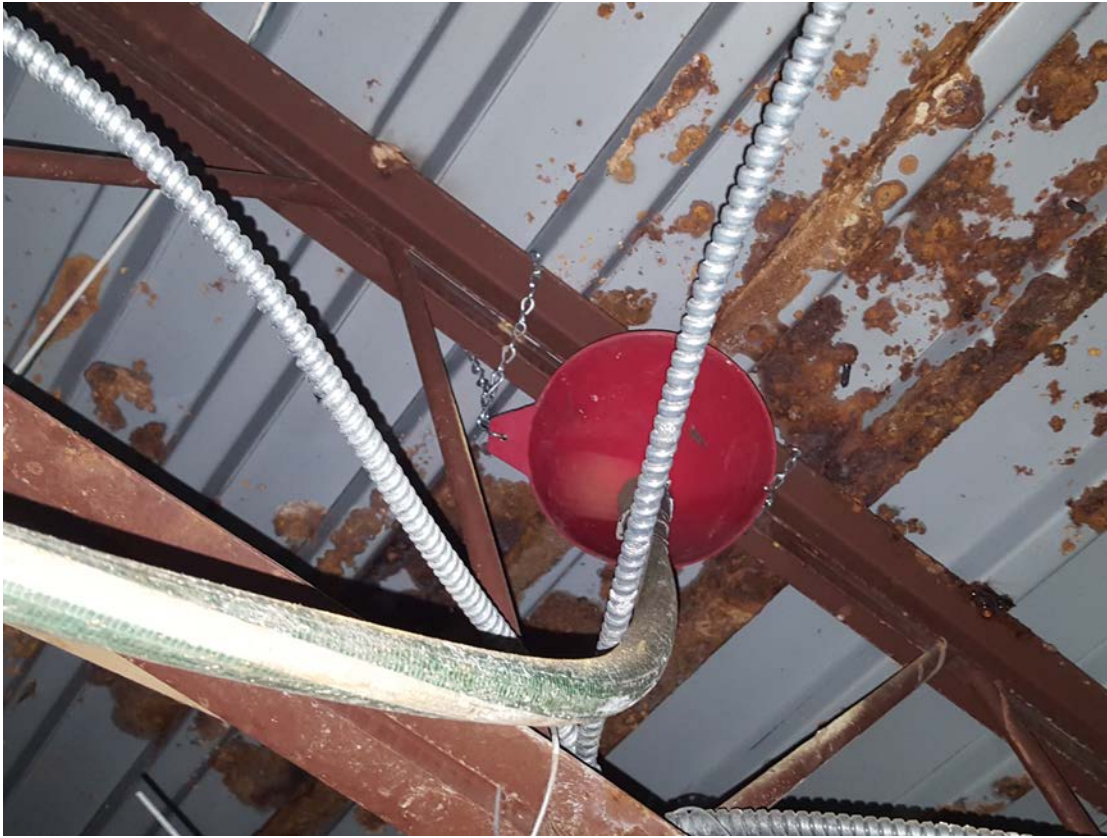
Photo #25 – Deteriorated Metal Roof Deck Plus Makeshift Drain & Hose.

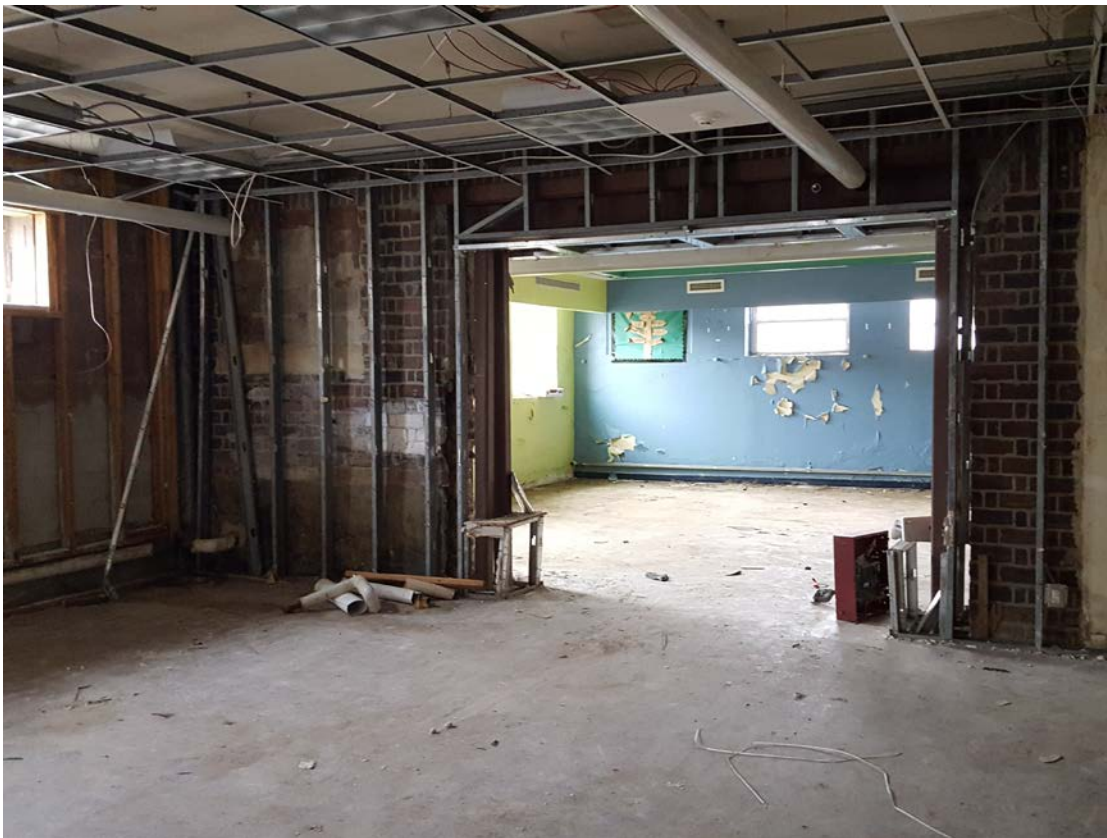
Photo #26 – Basement Level – Looking Southwest.

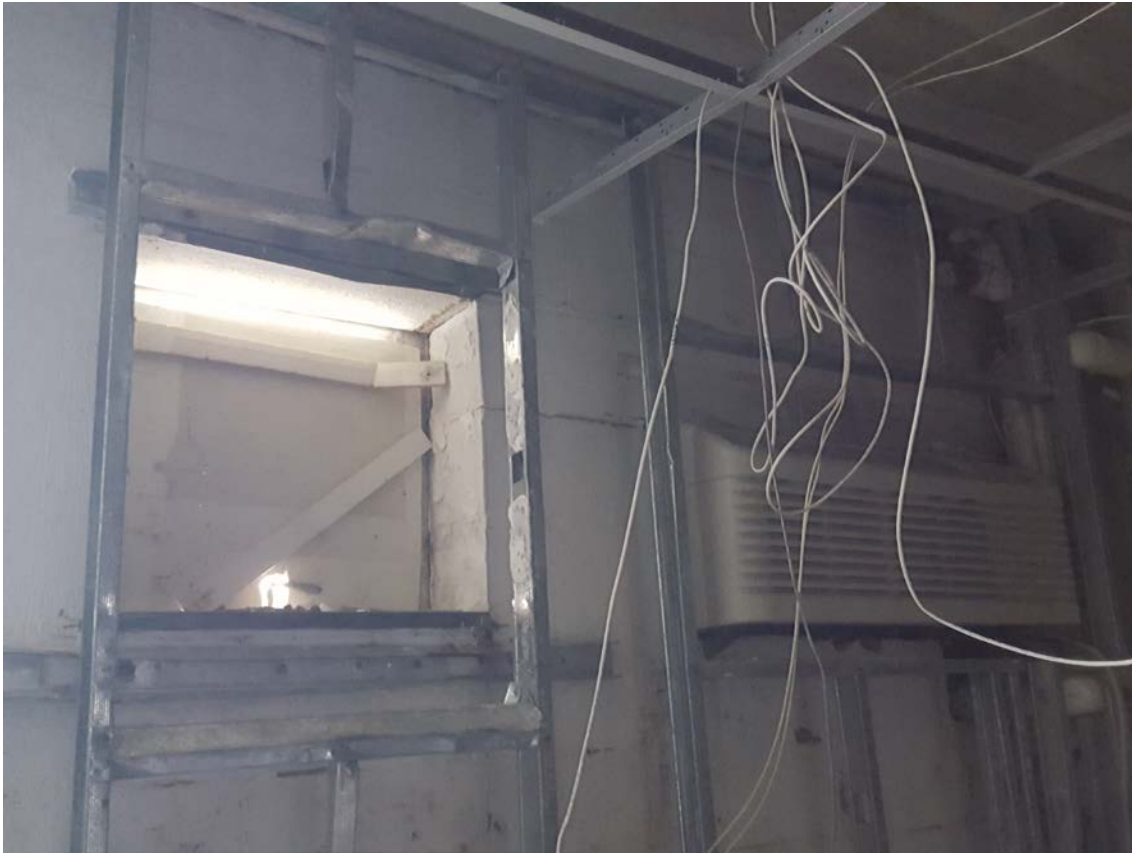
*Photo #31 – Horizontal Cracking Between Basement Openings – East Side.*
