Borough of Caldwell

Phase II Inflow and Infiltration Investigation

December 28, 2021

Extraneous Flow Evaluation

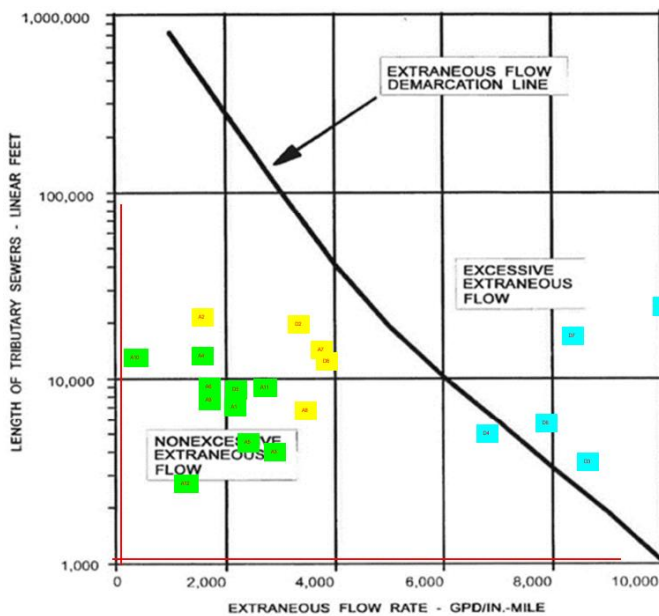
Figure 2: Mini-Basins with Excessive v. Non-Excessive Flow

Upon plotting the flow results for the twenty-one (21) mini-basins verse their corresponding in-mile values (**Figure 2**), the sub-basins with excessive extraneous flow are given below:

Utilizing the data as plotted against the USEPA Guideline for Excessive versus Non-Excessive Flow (**Figure 2**), Mott MacDonald focused further investigations (smoke testing / dyed water testing / closed-circuit television inspections) in the six (6) mini-basins that demonstrated excessive extraneous flow (B1 / C1 / D3 / D4 / D7 / D8) as well as five (5) mini-basins that demonstrated borderline excessive extraneous flow (A2 / A7 / A8 / B2 / D8).

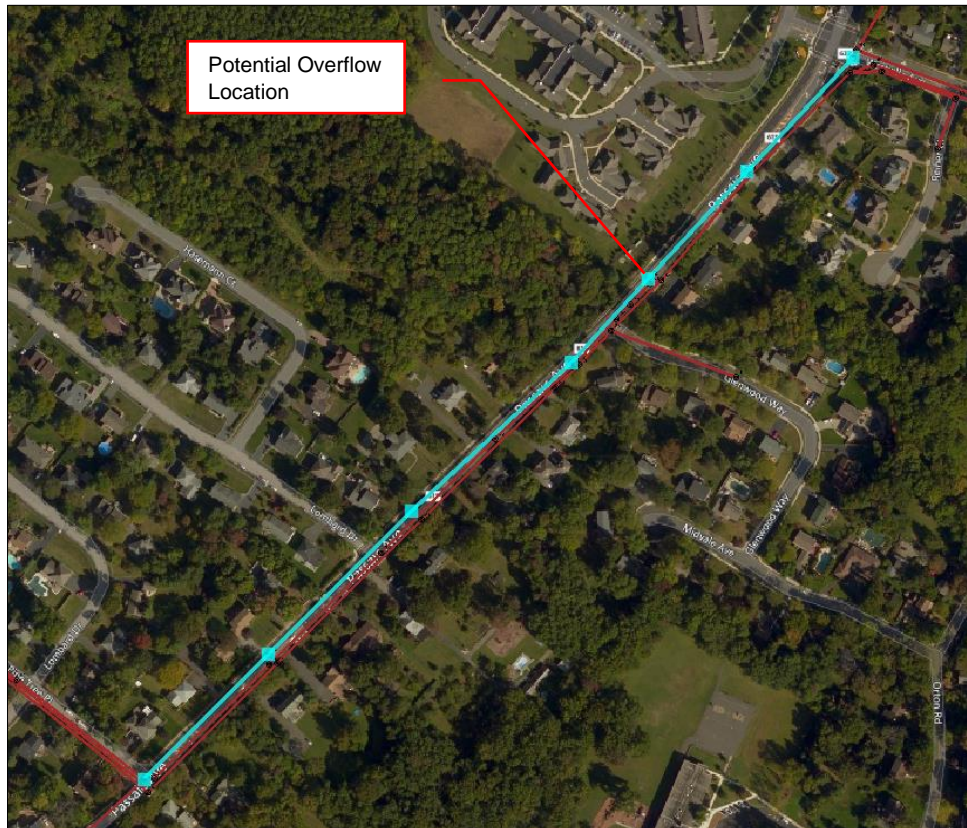
Figure 7: 15-inch dia. Passaic Avenue Interceptor Plan - Peak DWF Model

Model data tables and profiles were visually scanned for missing geometry, physical data values defaulted to null and adverse (i.e.: negative or flat) pipe slopes. The model was also reviewed for likely points of early failure. For example, **Figure 7** and **Figure 8** show a potential surface overflow location along Passaic Avenue.

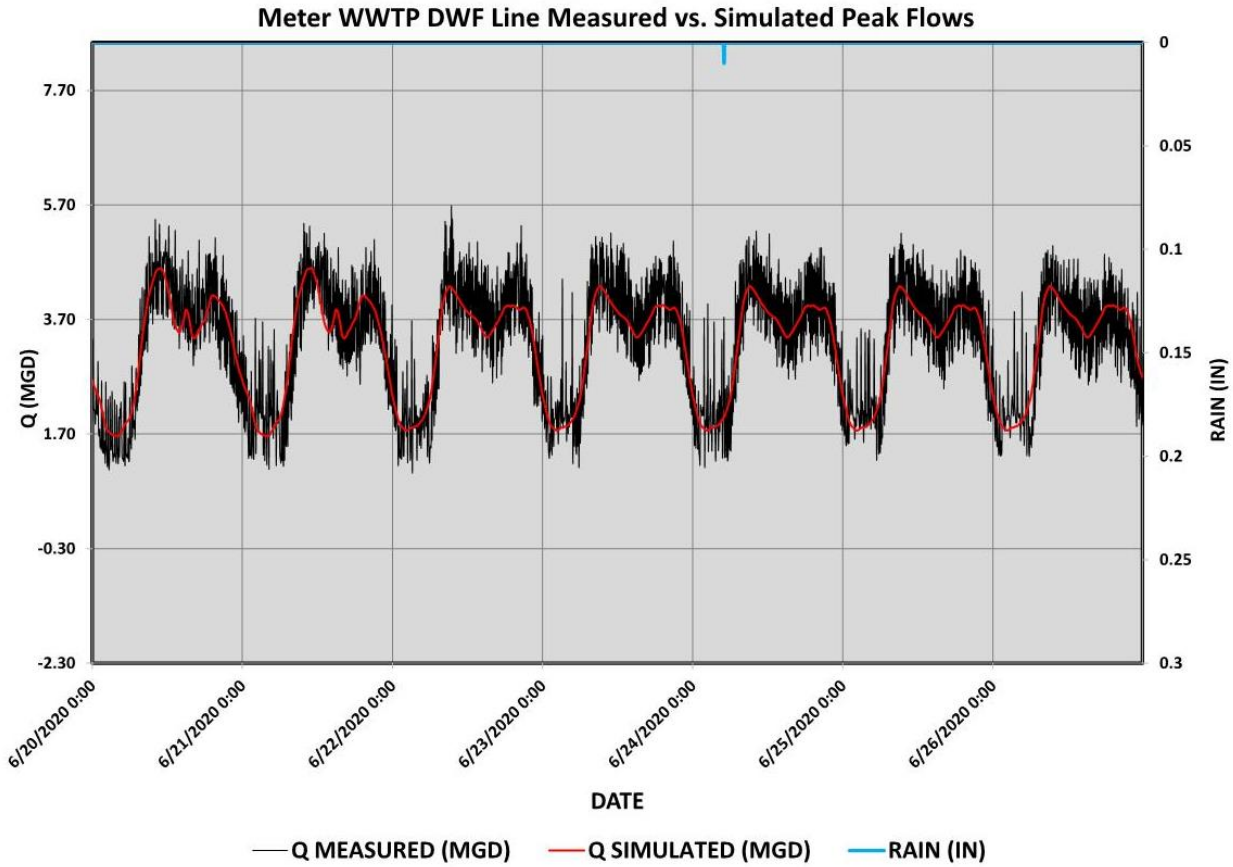
Figure 11: Comparison of Metered and Modeled Dry Weather Flows at WWTP Inflow

Figure 11 is an example comparison of measured vs. simulated flows for Dry Weather Flow calibration. Similar plots for all meters are provided in **Appendix I**. As per the CIWEM criteria, the timing and shape of the modeled flow matches well with the monitored flow.

Excessive peak flow deviations between the modeled and metered flow were noted for five (5) of the six (6) meters. As previously mentioned in this Report, the metered data noise is associated with lower flow magnitude and the presence of pump stations, and when the noise is filtered out the agreement is much improved. The results of dry weather flow calibration are presented in **Table 36**.
